# ANNUAL REPORT FOR 2006

**Smith Creek Mitigation Site**  
**New Hanover County**  
**TIP No. U-92 A/B**

Prepared By:  
Natural Environment Unit & Roadside Environmental Unit  
North Carolina Department of Transportation  
December 2006

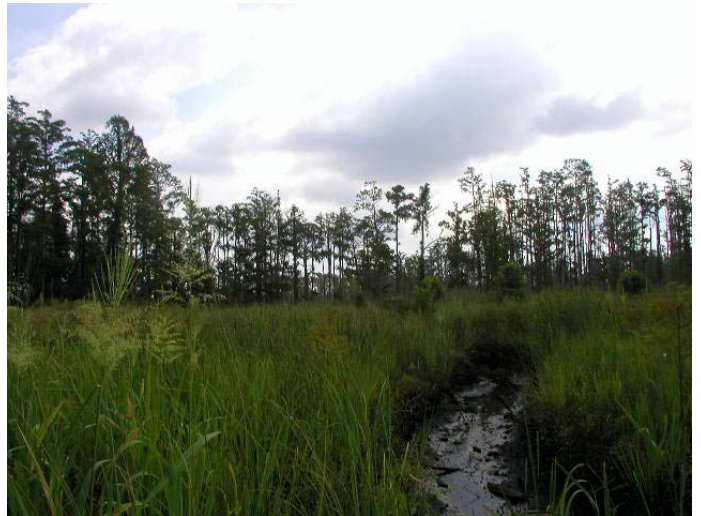
Photo 4

During the 2006 monitoring evaluation, the photo point for photos 4, 5 and 6 had to be relocated from the parkway bridge to down in the site due to traffic being turned onto the Smith Creek Parkway.
